Manhole Inspection Summary

Manhole # S17GG_008MH

Location Address: **1534 MORELAND AVE**

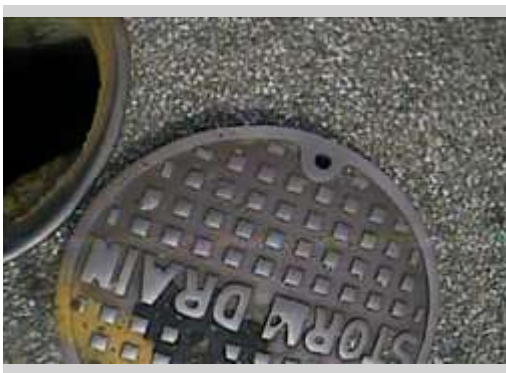
storm drain lid

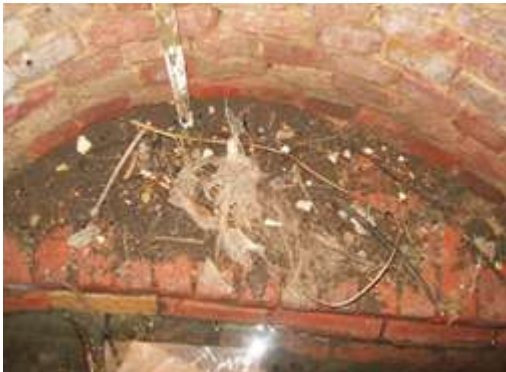
Defect 4

Condition: ☐ Sound ☐ Cracked ☐ Root Intrusion ☐ Deteriorated ☐ Leaks ☒ **Debris**

DEBRIS ON BENCH

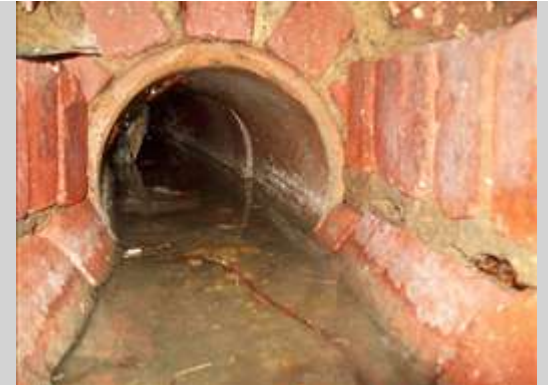
12 O'Clock Outflow

Pipe Height: **8.4** (in.) Rod and Bar (Angled)
Pipe Material: **Clay** ☐ Pipe Lined
Invert Depth: **8.07** (ft.) Flow Characteristics: **None**
Deposits: ☐ None ☐ Mud ☐ Sludge ☒ Debris ☐ Grease
Silt Depth: **3** (in.) Deposits Extent: **Medium**
Infiltration: **None** Pipe Seal Cond: **Sound**
